Atlantic Home Inspection Company LLC

Confidential Home Inspection Report

0 Main Street
Uptown
Maine
00000

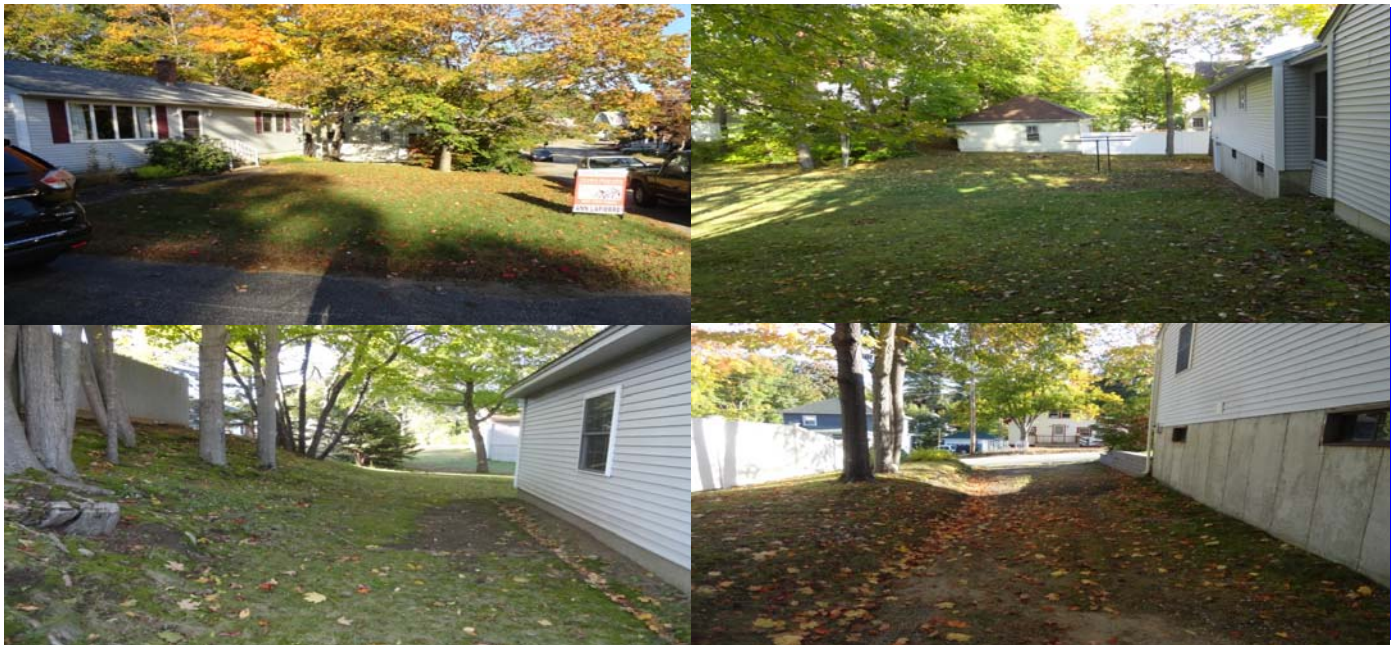
Item	Condition
I	NI	NP	R	D	Comments	
<input checked="" type="checkbox"/>	<input type="checkbox"/>	<input type="checkbox"/>	<input checked="" type="checkbox"/>	<input type="checkbox"/>	Driveway and walkway	Repair
					There is a potential trip hazard where the driveway meets the concrete floor of the garage. Recommend to repair as needed.	
<input checked="" type="checkbox"/>	<input type="checkbox"/>	<input type="checkbox"/>	<input type="checkbox"/>	<input type="checkbox"/>	Front yard	Good
<input checked="" type="checkbox"/>	<input type="checkbox"/>	<input type="checkbox"/>	<input type="checkbox"/>	<input type="checkbox"/>	Back yard	Good
<input type="checkbox"/>	<input type="checkbox"/>	<input checked="" type="checkbox"/>	<input type="checkbox"/>	<input type="checkbox"/>	Decks	
<input checked="" type="checkbox"/>	<input type="checkbox"/>	<input type="checkbox"/>	<input checked="" type="checkbox"/>	<input type="checkbox"/>	Stairs	Maintenance needed

The brick stairs at the front of the home have gaps in the mortar, and a section of bricks has cracked on the right side. Recommend to repair the stairs as needed.	
<input checked="" type="checkbox"/>	<input type="checkbox"/>	<input type="checkbox"/>	<input checked="" type="checkbox"/>	<input type="checkbox"/>	Trees and shrubs	Maintenance needed
					Recommend to cut back the overhanging trees to prevent the debris and moisture to the roof. Recommend to cut back the shrubs to prevent moisture to the home.	
<input checked="" type="checkbox"/>	<input type="checkbox"/>	<input type="checkbox"/>	<input type="checkbox"/>	<input type="checkbox"/>	Grade	Good
<input checked="" type="checkbox"/>	<input type="checkbox"/>	<input type="checkbox"/>	<input type="checkbox"/>	<input type="checkbox"/>	Drainage	Good

The brick stairs at the front of the home have gaps in the mortar, and a section of bricks has cracked on the right side. Recommend to repair the stairs as needed.

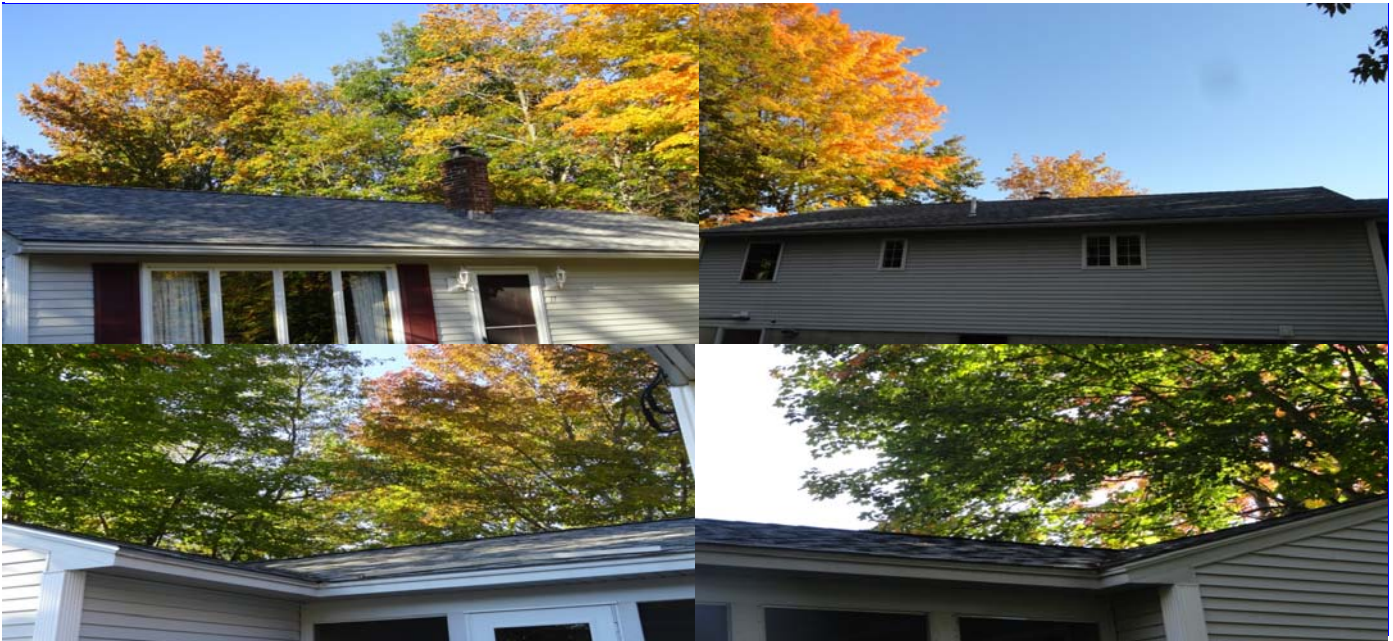
I	NI	NP	R	D	Item Comments	Condition
<input checked="" type="checkbox"/>	<input type="checkbox"/>	<input type="checkbox"/>	<input type="checkbox"/>	<input type="checkbox"/>	Shingles The home has architectural shingles.	Good
<input checked="" type="checkbox"/>	<input type="checkbox"/>	<input type="checkbox"/>	<input type="checkbox"/>	<input type="checkbox"/>	Ridge vent	Good
<input checked="" type="checkbox"/>	<input type="checkbox"/>	<input type="checkbox"/>	<input type="checkbox"/>	<input type="checkbox"/>	Roof deck	Good
<input checked="" type="checkbox"/>	<input type="checkbox"/>	<input type="checkbox"/>	<input type="checkbox"/>	<input type="checkbox"/>	Flashing	Good
<input checked="" type="checkbox"/>	<input type="checkbox"/>	<input type="checkbox"/>	<input checked="" type="checkbox"/>	<input checked="" type="checkbox"/>	Ventilation See attic space for more information.	Repair
<input checked="" type="checkbox"/>	<input type="checkbox"/>	<input type="checkbox"/>	<input type="checkbox"/>	<input type="checkbox"/>	Drip and rake edges	Good

<input checked="" type="checkbox"/>	<input type="checkbox"/>	<input type="checkbox"/>	<input type="checkbox"/>	<input type="checkbox"/>	Gutters, downspouts	Good
<input checked="" type="checkbox"/>	<input type="checkbox"/>	<input type="checkbox"/>	<input type="checkbox"/>	<input type="checkbox"/>	Age Architectural shingles have an approximate life span of 30 years. Roof installed in 2008 (7 years old).	Good

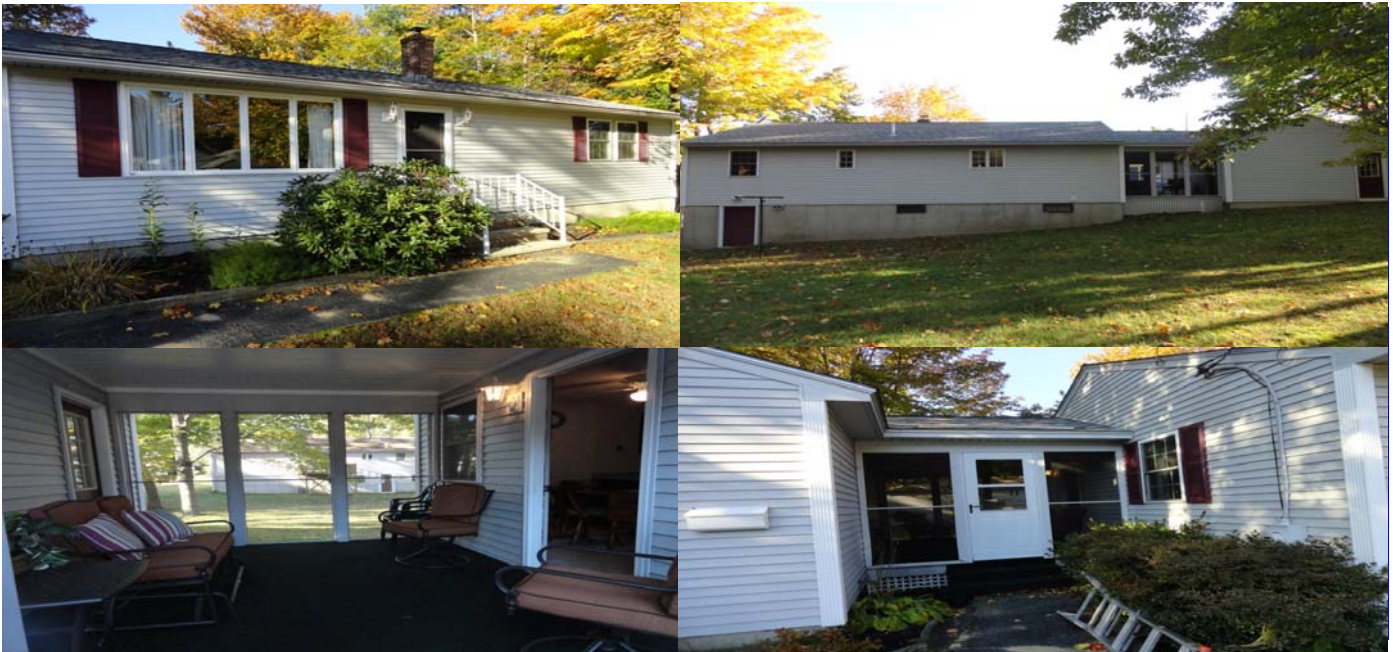
D					Item	Condition
					Comments	
<input checked="" type="checkbox"/>	<input type="checkbox"/>	<input type="checkbox"/>	<input type="checkbox"/>	<input type="checkbox"/>	Siding	Good
					The home has vinyl siding.	
<input checked="" type="checkbox"/>	<input type="checkbox"/>	<input type="checkbox"/>	<input checked="" type="checkbox"/>	<input checked="" type="checkbox"/>	Fascia, soffits, trim	Good
					The home has aluminum wrapped trim. There is wood trim around the screened porch with some decay. The door jamb of the front door has some decay. Recommend to repair as	
<input checked="" type="checkbox"/>	<input type="checkbox"/>	<input type="checkbox"/>	<input type="checkbox"/>	<input type="checkbox"/>	Doors	Good

<input checked="" type="checkbox"/>	<input type="checkbox"/>	<input type="checkbox"/>	<input type="checkbox"/>	<input type="checkbox"/>	Screened Porch	Re-evaluate
					Due to the skirting around the screened porch, it could not be determined if the porch is lag bolted to the home and garage. Recommend to re-evaluate and lag bolt as needed.	
<input type="checkbox"/>	<input type="checkbox"/>	<input checked="" type="checkbox"/>	<input type="checkbox"/>	<input type="checkbox"/>	Stairs, Bulkhead	
<input checked="" type="checkbox"/>	<input type="checkbox"/>	<input type="checkbox"/>	<input type="checkbox"/>	<input type="checkbox"/>	Water faucets	Good
<input checked="" type="checkbox"/>	<input type="checkbox"/>	<input type="checkbox"/>	<input type="checkbox"/>	<input type="checkbox"/>	Window wells, crawl space vents	Good

The home has aluminum wrapped trim. There is wood trim around the screened porch with some decay. The door jamb of the front door has some decay. Recommend to repair as needed.

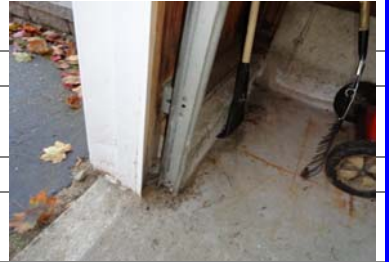
Item Comments	Condition
<input checked="" type="checkbox"/>	<input type="checkbox"/>	<input type="checkbox"/>	<input type="checkbox"/>	<input type="checkbox"/>	Siding	Good
<input checked="" type="checkbox"/>	<input type="checkbox"/>	<input type="checkbox"/>	<input type="checkbox"/>	<input type="checkbox"/>	Fascia, soffits, trim	Good
<input checked="" type="checkbox"/>	<input type="checkbox"/>	<input type="checkbox"/>	<input type="checkbox"/>	<input type="checkbox"/>	Service Door, Window	Good
<input checked="" type="checkbox"/>	<input type="checkbox"/>	<input type="checkbox"/>	<input type="checkbox"/>	<input type="checkbox"/>	Fire Separation from living space	Good
<input checked="" type="checkbox"/>	<input type="checkbox"/>	<input type="checkbox"/>	<input checked="" type="checkbox"/>	<input checked="" type="checkbox"/>	Overhead door(s)	Safety hazard The automatic garage door does not have safety sensors. Recommend to install sensors.

<input checked="" type="checkbox"/>	<input type="checkbox"/>	<input type="checkbox"/>	<input checked="" type="checkbox"/>	<input checked="" type="checkbox"/>	Electric	Safety hazard There is no GFCI outlet in the garage. Install a GFCI outlet.
<input type="checkbox"/>	<input type="checkbox"/>	<input checked="" type="checkbox"/>	<input type="checkbox"/>	<input type="checkbox"/>	Water faucets	
<input type="checkbox"/>	<input type="checkbox"/>	<input checked="" type="checkbox"/>	<input type="checkbox"/>	<input type="checkbox"/>	Window wells, crawl space vents

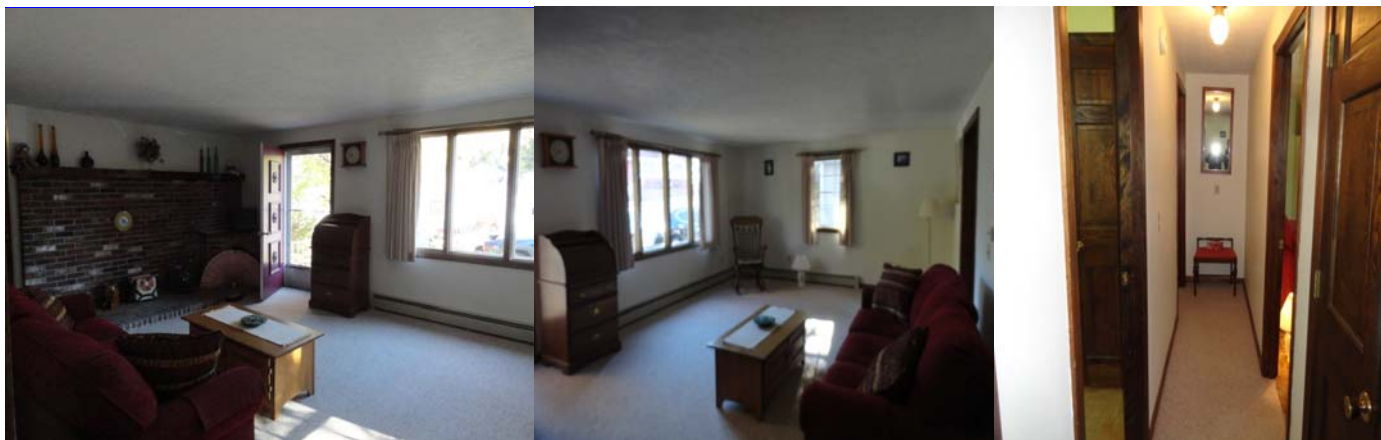
Comments	Item
	Doors and windows
	Floor
	Walls and ceilings
There is a section of brick wall in the living room where there are some small gaps in the mortar. Recommend to re-point the brick wall as needed.	
	Closet
	Electrical and lighting
There is an outlet in the living room that tested open ground and one that tested reverse polarity. Recommend to have a professional repair as needed.	
	Doors and windows
	Floor
	Walls and ceilings
	Closet
	Electrical and lighting

There is a section of brick wall in the living room where there are some small gaps in the mortar. Recommend to re-point the brick wall as needed.

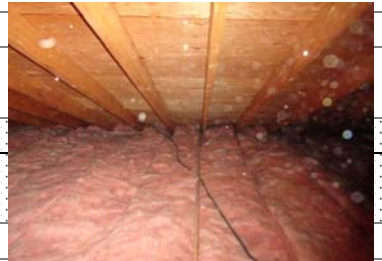
I = Inspected NI = Not Inspected NP = Not Present R = Repair Needed D = Defective						
I	NI	NP	R	D	Item Comments	Condition
<input checked="" type="checkbox"/>	<input type="checkbox"/>	<input type="checkbox"/>	<input type="checkbox"/>	<input type="checkbox"/>	Access	Good
The access panel is in the bathroom closet. Recommend to install a piece of foam insulation board on the back side of the access panel to help prevent air flow to the first floor.						
<input checked="" type="checkbox"/>	<input type="checkbox"/>	<input type="checkbox"/>	<input type="checkbox"/>	<input type="checkbox"/>	Insulation	Good
2 layers of batt insulation.						
<input checked="" type="checkbox"/>	<input type="checkbox"/>	<input type="checkbox"/>	<input type="checkbox"/>	<input type="checkbox"/>	Moisture	Good
There is a sign of previous moisture around the chimney in the attic space. This was prior to the new roof and flashing installed.

The access panel is in the bathroom closet. Recommend to install a piece of foam insulation board on the back side of the access panel to help prevent air flow to the first floor.

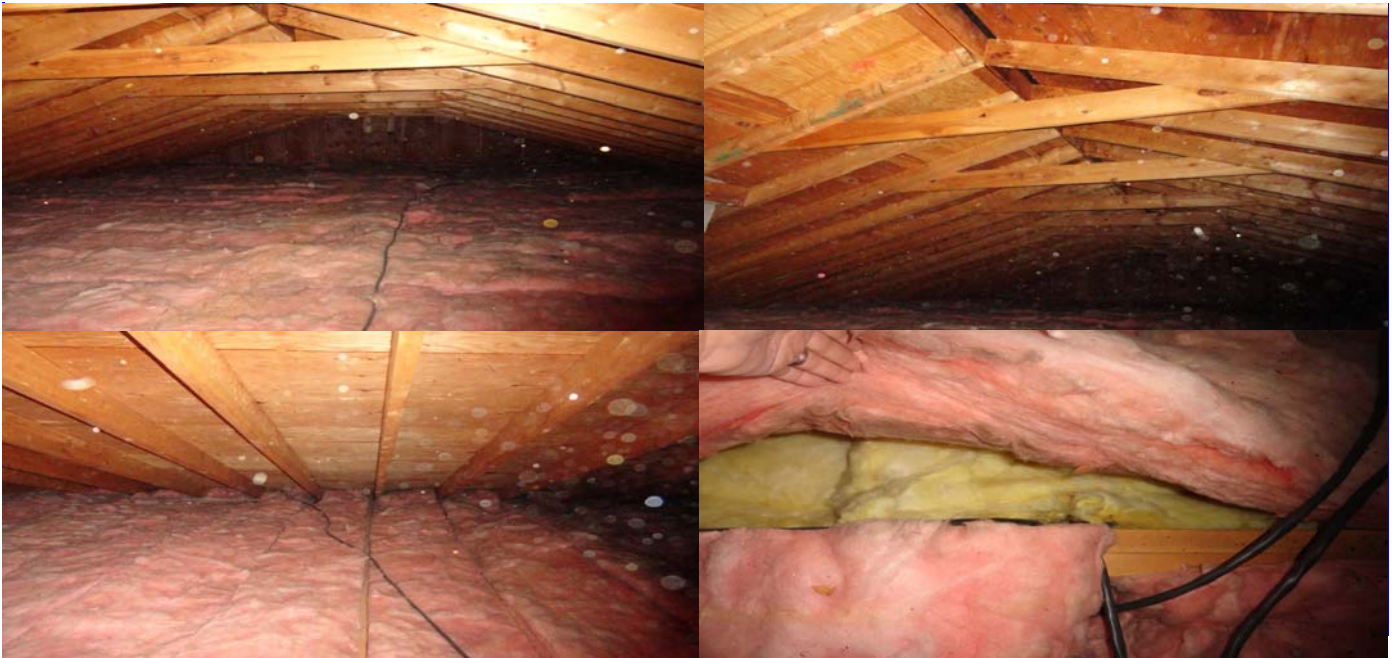
<input checked="" type="checkbox"/>	<input type="checkbox"/>	<input type="checkbox"/>	<input type="checkbox"/>	<input type="checkbox"/>	Stains	Good
<input checked="" type="checkbox"/>	<input type="checkbox"/>	<input type="checkbox"/>	<input type="checkbox"/>	<input type="checkbox"/>	Rafters	Good
<input type="checkbox"/>	<input type="checkbox"/>	<input checked="" type="checkbox"/>	<input type="checkbox"/>	<input type="checkbox"/>	Trusses	
<input checked="" type="checkbox"/>	<input type="checkbox"/>	<input type="checkbox"/>	<input checked="" type="checkbox"/>	<input checked="" type="checkbox"/>	Ventilation	Repair
There are no attic baffles and the insulation is stuffed into the soffits so there is no airflow from the ridge vent through the soffit vents. Recommend to install attic baffles to improve						
<input type="checkbox"/>	<input type="checkbox"/>	<input checked="" type="checkbox"/>	<input type="checkbox"/>	<input type="checkbox"/>	Attic baffles

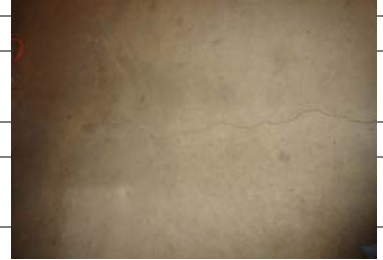
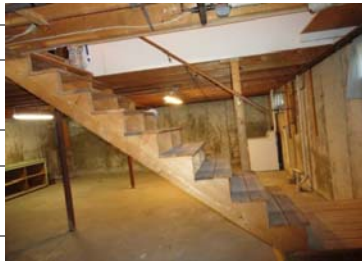
I = Inspected NI = Not Inspected NP = Not Present R = Repair Needed D = Defective						
I	NI	NP	R	D	Item Comments	Condition
<input checked="" type="checkbox"/>	<input type="checkbox"/>	<input type="checkbox"/>	<input type="checkbox"/>	<input type="checkbox"/>	Foundation walls Poured concrete foundation walls.	Good
<input checked="" type="checkbox"/>	<input type="checkbox"/>	<input type="checkbox"/>	<input type="checkbox"/>	<input type="checkbox"/>	Support beam	Good
<input checked="" type="checkbox"/>	<input type="checkbox"/>	<input type="checkbox"/>	<input type="checkbox"/>	<input type="checkbox"/>	Floor joists	Good
<input checked="" type="checkbox"/>	<input type="checkbox"/>	<input type="checkbox"/>	<input type="checkbox"/>	<input type="checkbox"/>	Support posts	Good
<input checked="" type="checkbox"/>	<input type="checkbox"/>	<input type="checkbox"/>	<input checked="" type="checkbox"/>	<input type="checkbox"/>	Floor, slab There is a settlement crack in the basement concrete floor. Recommend to monitor and repair as needed.	Monitor

<input checked="" type="checkbox"/>	<input type="checkbox"/>	<input type="checkbox"/>	<input type="checkbox"/>	<input type="checkbox"/>	Moisture	Good
<input checked="" type="checkbox"/>	<input type="checkbox"/>	<input type="checkbox"/>	<input type="checkbox"/>	<input type="checkbox"/>	Sump pit	Good
<input checked="" type="checkbox"/>	<input type="checkbox"/>	<input type="checkbox"/>	<input checked="" type="checkbox"/>	<input checked="" type="checkbox"/>	Stairs/rail There is no handrail on the right side of the stairs to the basement. Recommend to install a railing.	Safety hazard

There is no handrail on the right side of the stairs to the basement. Recommend to install a railing.

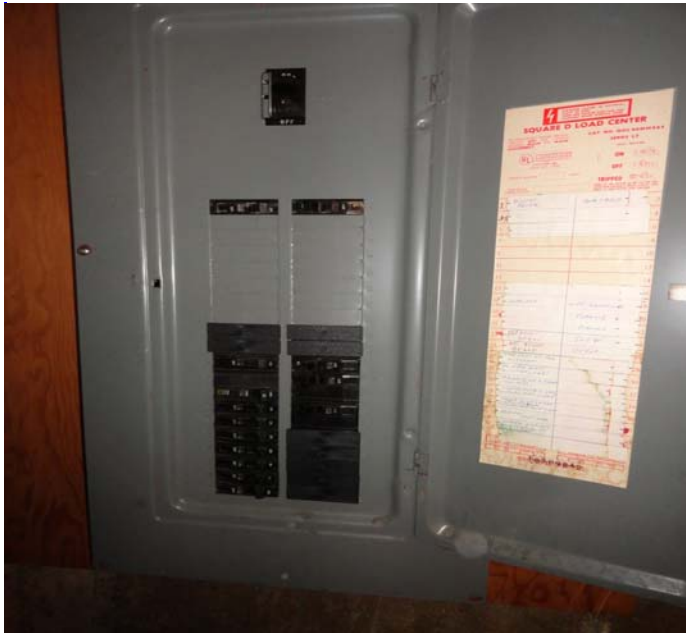
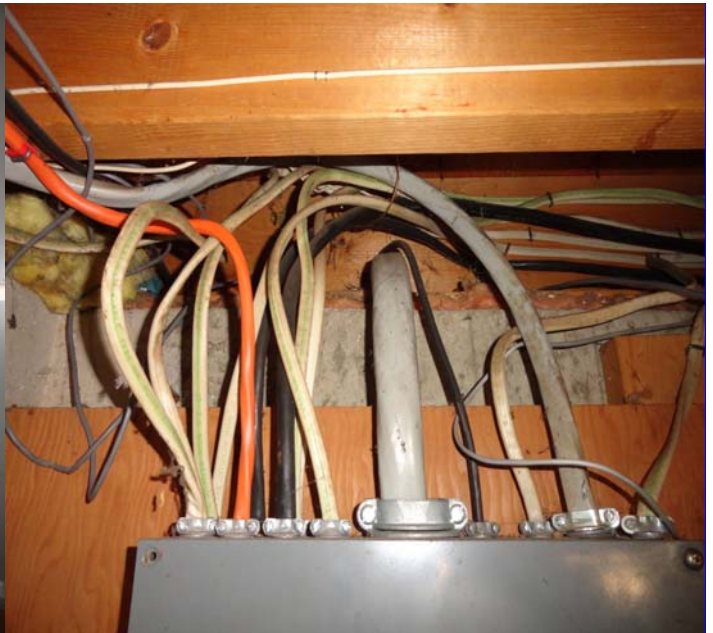
<input checked="" type="checkbox"/>	<input type="checkbox"/>	<input type="checkbox"/>	<input checked="" type="checkbox"/>	<input checked="" type="checkbox"/>	Main panel	Safety hazard	
There are missing screws that secure the electrical panel cover to the panel. Recommend to install screws.							
<input checked="" type="checkbox"/>	<input type="checkbox"/>	<input type="checkbox"/>	<input type="checkbox"/>	<input type="checkbox"/>	Main breaker/disconnect	Good	
200 amp main breaker.							
<input checked="" type="checkbox"/>	<input type="checkbox"/>	<input type="checkbox"/>	<input type="checkbox"/>	<input type="checkbox"/>	Made electrode - Water line	Good

<input checked="" type="checkbox"/>	<input type="checkbox"/>	<input type="checkbox"/>	<input type="checkbox"/>	<input type="checkbox"/>	Made electrode - Ground rod	Good	
<input checked="" type="checkbox"/>	<input type="checkbox"/>	<input type="checkbox"/>	<input checked="" type="checkbox"/>	<input checked="" type="checkbox"/>	Branch circuits	Safety hazard

There are outlets in some rooms of the home that tested open ground and reverse polarity. There is no GFCI outlet in the kitchen. There is an open junction box in the basement. See							
<input type="checkbox"/>	<input type="checkbox"/>	<input checked="" type="checkbox"/>	<input type="checkbox"/>	<input type="checkbox"/>	GFCI breakers		
<input checked="" type="checkbox"/>	<input type="checkbox"/>	<input type="checkbox"/>	<input checked="" type="checkbox"/>	<input checked="" type="checkbox"/>	Smoke Detectors	Install	
There should be at least one smoke detector on each level and one CO detector to every home. There is no CO detector in the home. There is no smoke detector in the basement.

There are outlets in some rooms of the home that tested open ground and reverse polarity. There is no GFCI outlet in the kitchen. There is an open junction box in the basement. See above for more specifics. Recommend to have a professional make the needed electrical repairs.

There should be at least one smoke detector on each level and one CO detector to every home. There is no CO detector in the home. There is no smoke detector in the basement. Recommend to install a CO and a smoke detector.
